Northwest Missouri Regional Road Safety Assessment Program

US Highway 36 & Ensign Trace Intersection
Cameron, Missouri

Conducted May 3, 2019

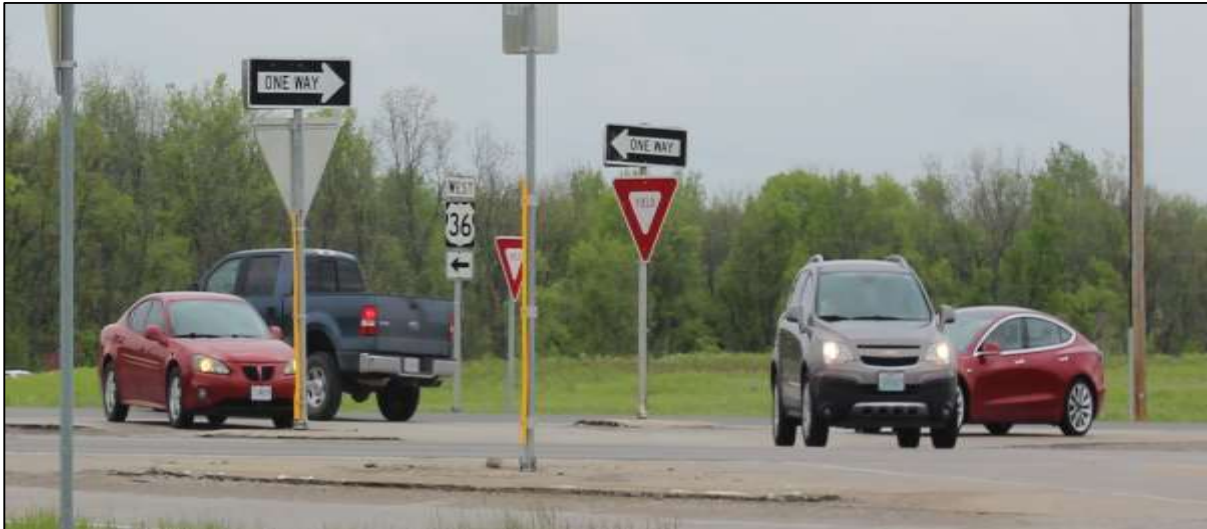
Figure 14 – Multiple Vehicles in the Median at the Intersection

- 1) **Line of Sight** – The RSA team agreed that the line of sight was sufficient but there is a lot for motorists to keep track of since cars are approaching from multiple directions at different speeds. It is possible that vehicles seem to be further away than what they actually are.

No remedies suggested. However, remedies were suggested in several other categories that would make moving through the intersection easier for motorists.

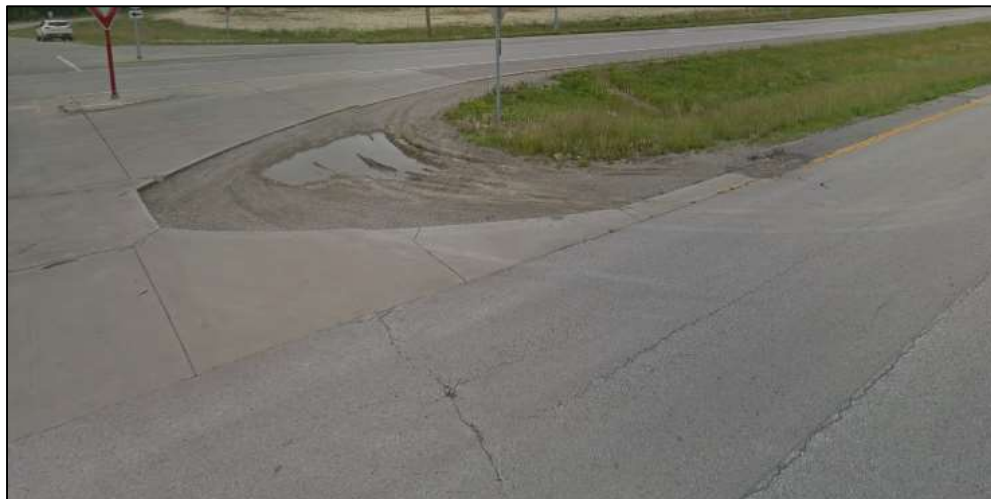
Figure 15 – Pavement Conditions

- 2) **Pavement** - Several potholes and shoulder drop-offs were observed.

- Repair the potholes and the drop-offs on the edge of the shoulder.

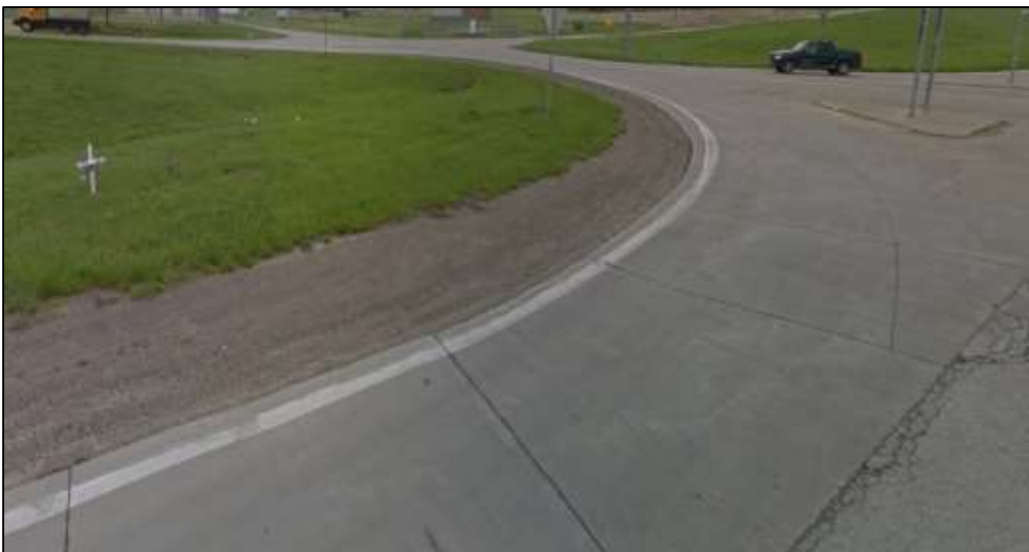
Figure 17 – Gravel Shoulders

- 3) **Shoulders** – There are 10-foot wide paved shoulders until the turn lanes begin for the intersection. At the intersection the paved shoulders narrow to and there are gravel shoulders extending beyond the narrower paved shoulders. The gravel shoulders appear worn and, as mentioned under the previous category, there are shoulder drop-offs.

- Perform shoulder maintenance and replace gravel shoulders with concrete.

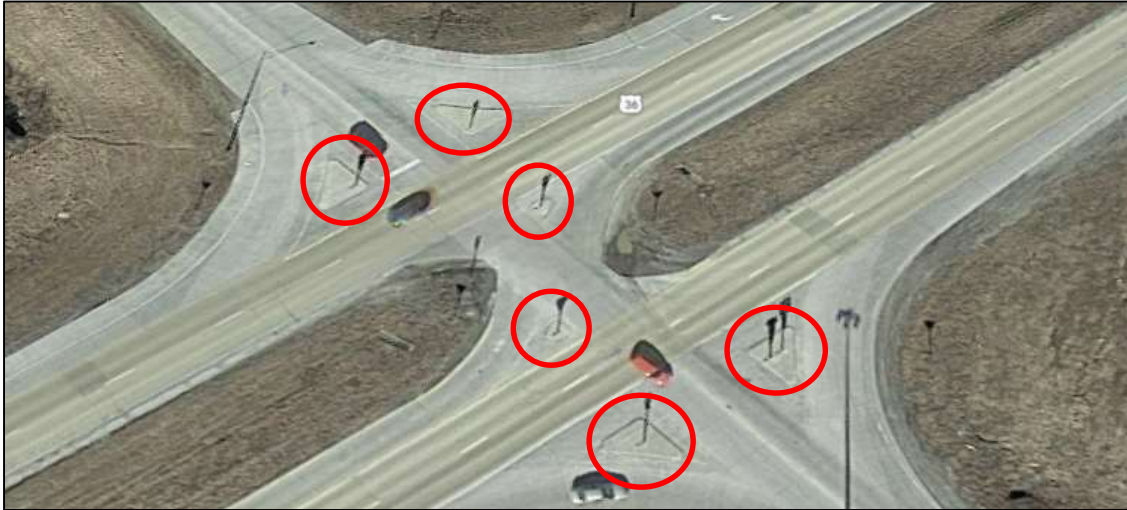
Figure 20– Six Islands in the Intersection

- 4) **Rumble Strips, Guard Rails, Islands** – Rumble strips are present on both east and west bound US Highway 36, which stop at turning lanes. There are no guard rails and there was no mention of guard rails being needed at this location. There are six islands in the intersection creating a physical separation for vehicles traveling in different directions. It

was observed that the paint on the islands has faded and that some of the bases are crumbling.

- Paint and repair the crumbling islands to improve visibility.

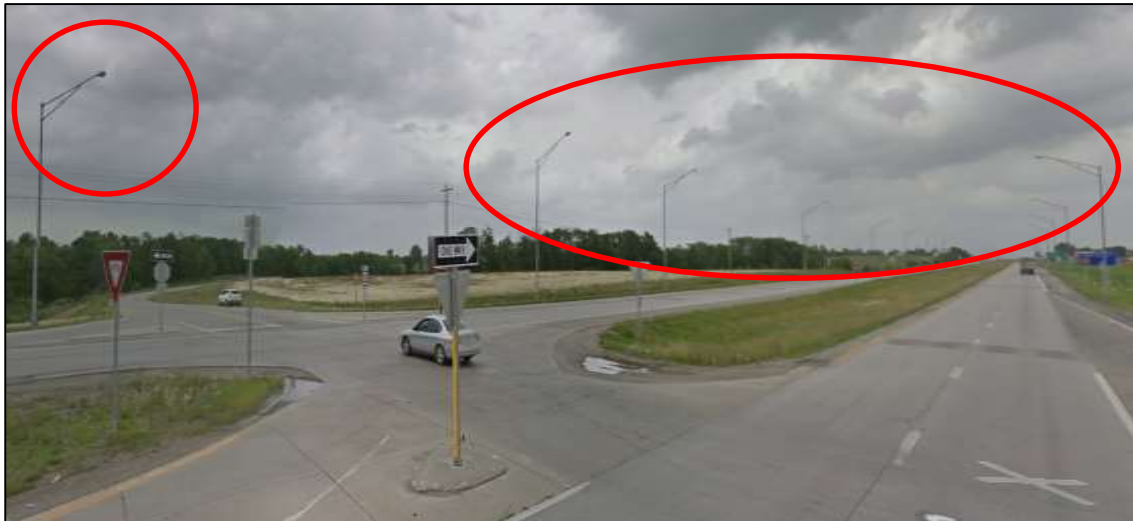
Figure 22– Street Lighting at Intersection

- 5) **Lighting** – The RSA team concluded that the street lamps lining both sides of US Highway 36 provided sufficient illumination at the intersection, as well as approaching the intersection.

No remedies suggested.

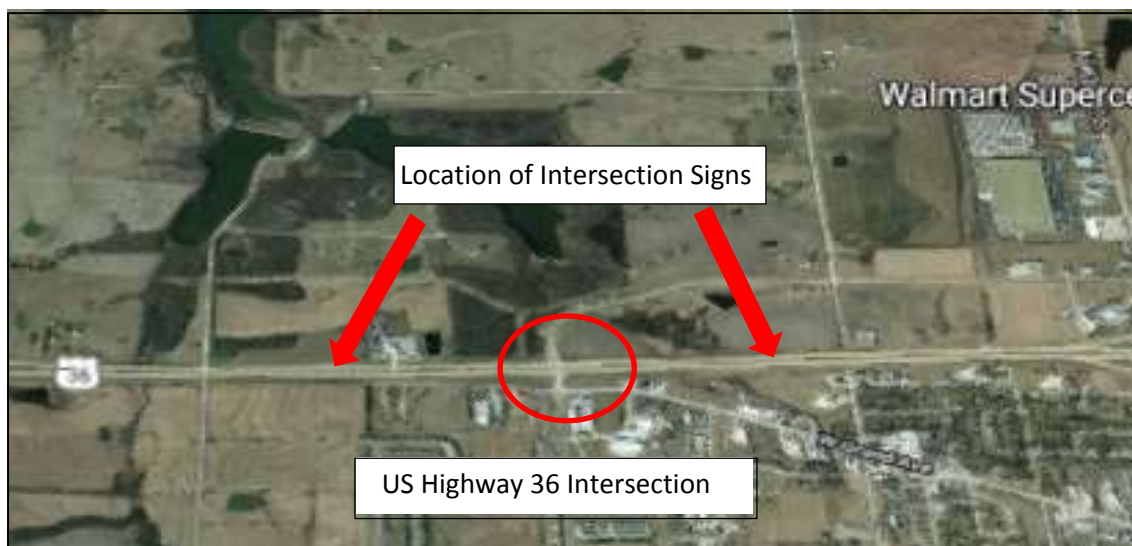
Figure 23 – Location of “Intersection Ahead” Signs

- 6) **Signage** – Signage at the intersection was listed on pages 11 and 12. It was observed that the yield signs at the intersection were 48”, not 60” and the divided highway stub should be placed on the sign. There is additional signage informing motorists of an intersection ahead on both east and westbound US Highway 36. The signage in both directions consists of two “intersection ahead” signs, with one having a flashing yellow light above the sign.

- Add another flashing sign on both westbound and eastbound lanes.

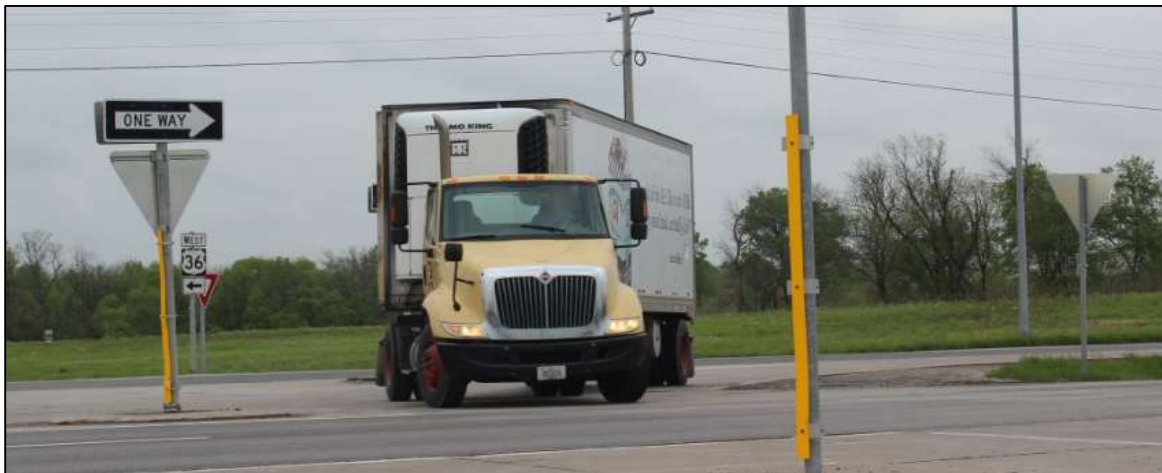
Figure 29 – Semi Navigating Through the Intersection

- 7) **Turning and Acceleration Lanes** – There are several turning lanes and acceleration lanes at the intersection, and the restrictive turning movements seemed to be causing the most problems. The median didn't appear to have a lot of room when there were several cars or a semi-truck needing to turn. This category received the most focus and several of the suggestions included closing some of the turning lanes at the intersection and opening up turning lanes at a nearby location. However, there was concern about emergency vehicles losing the ability to cross over at this intersection, and the possibility of traffic backing up.
