Northwest Missouri Regional Road Safety Assessment Program

US Highway 36 & Ensign Trace Intersection
Cameron, Missouri

Conducted May 3, 2019

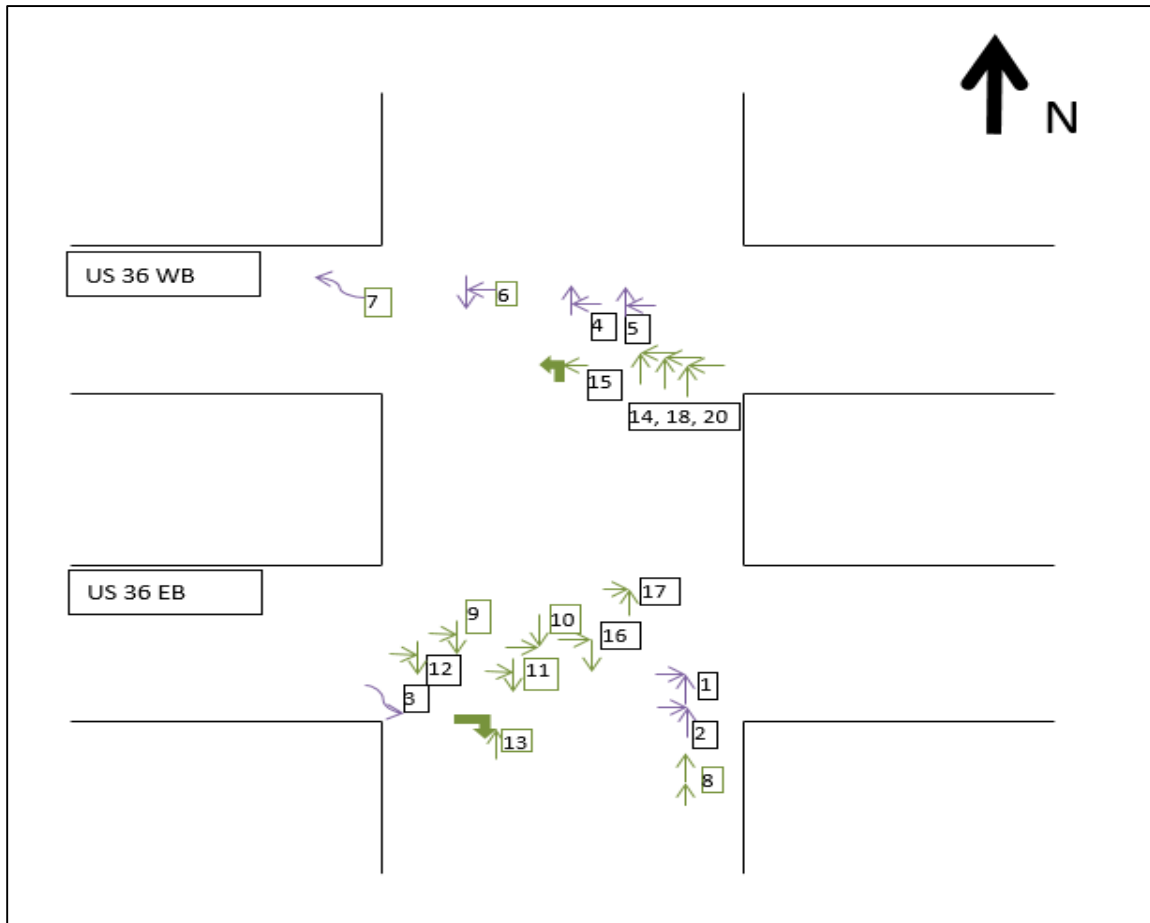
Figure 6 – Crash Diagram

MoDOT provided a crash diagram, locating where a crash occurred in the intersection from 2014 to 2018, as well as a table with additional information that corresponds with the diagram. Both disabling crashes occurred in the northbound lane, due to the driver losing control of the vehicle. Eleven of the 20 crashes were right angle crashes. Additional crash data has been included in Appendix A.

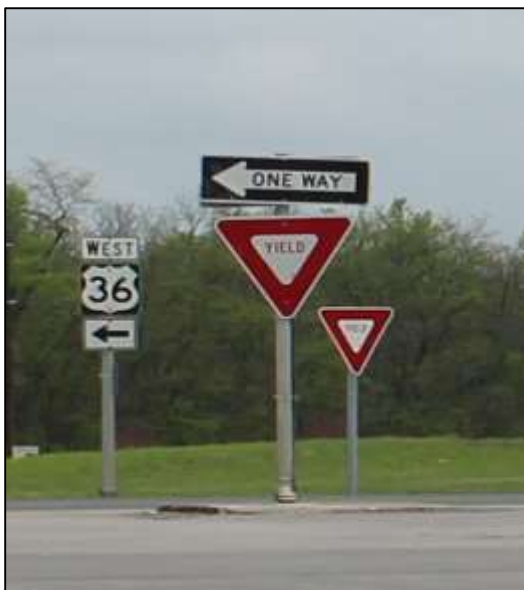
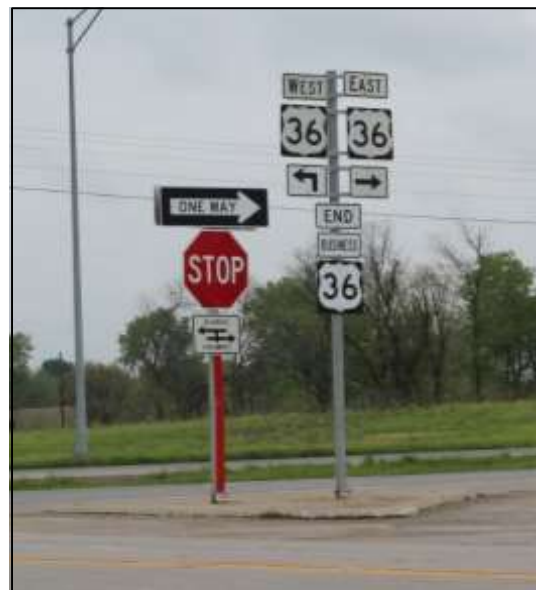
Figure 12 – Signage at US Highway 36 and Ensign Trace

The signage at the intersection includes stop and yield warning signs, as well as one way and divided highway signs.
